**HUB CITY
IRON WORKS**

PCM Backplate Plain Linear Bearing Upgrade

The PCM Backplate Plain Linear Bearing Upgrade!

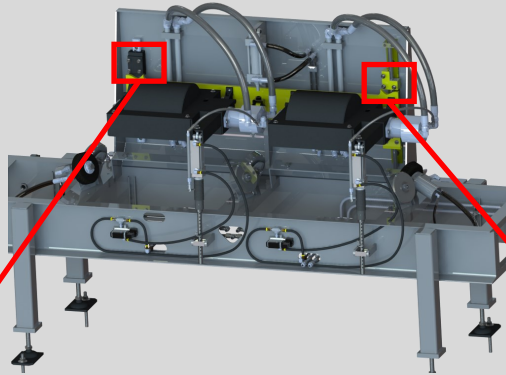
- Ball bearing design is more prone to failure, especially if not greased.
- Requires more maintenance.

- Frelon type plain bearing requires no maintenance.
- Inherently less prone to failure due to less moving parts.
- Sealed with Rod Wiper to keep out contaminants.
- Chrome plates rod provides excellent rust protection.
- Reverse compatible with most Hub City machines
- Plain bearings can be replaced much more cost effectively.

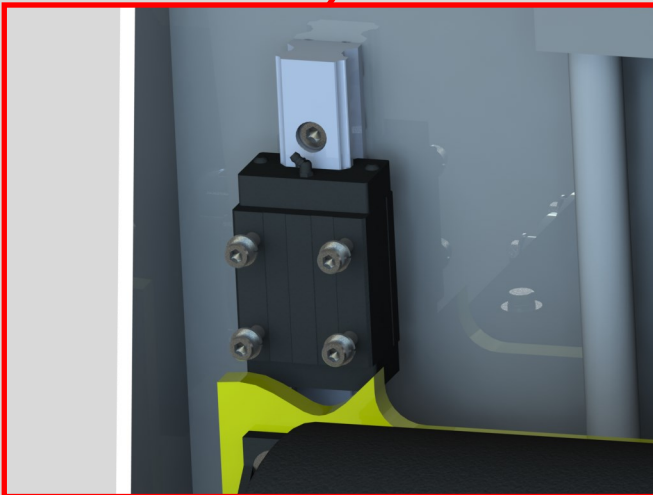
Standard ball bearing type linear bearing shown.

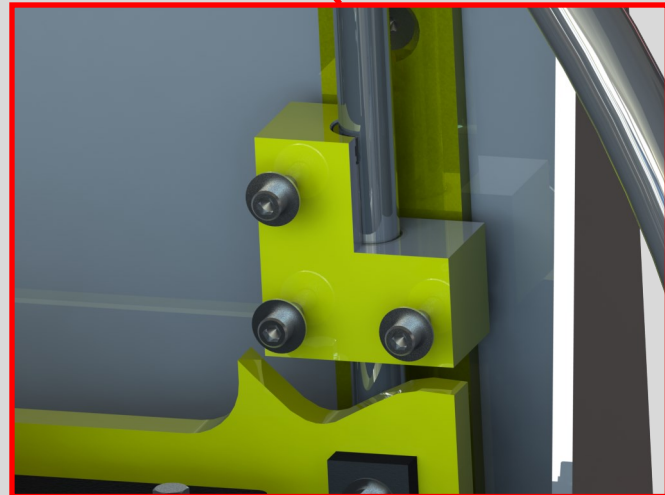
Upgraded Plain Bearing and Rod style Rail shown. (Cutaway shown for clarity)
